OPERATING EXPERIENCE SUMMARY

Office of Nuclear and Facility Safety

February 1 – February 14, 2000

Summary 2000-03

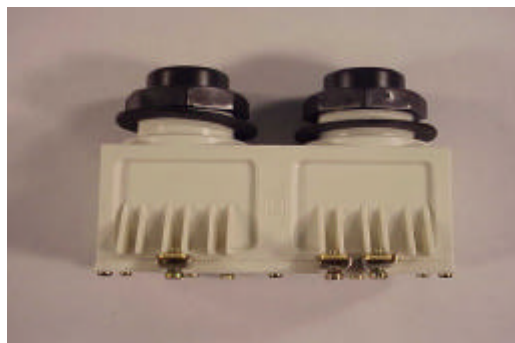
SKRU__ Multispeed Operator

Typically, devices will be found mounted in SKYP Pendant Stations, or other types of control stations. To inspect the SKRU device, you will need to open the pendant or panel to access the product nameplate on the end of the device.

Turn off power supplying the pendant station or control station before opening the device to inspect the date code.
